REPORT ON PORTSMOUTH CATHEDRAL WORKS – REPLACEMENT OF THE NAVE ROOF AND REPAIR AND REDECORATION OF THE TOWER AND CUPOLA.

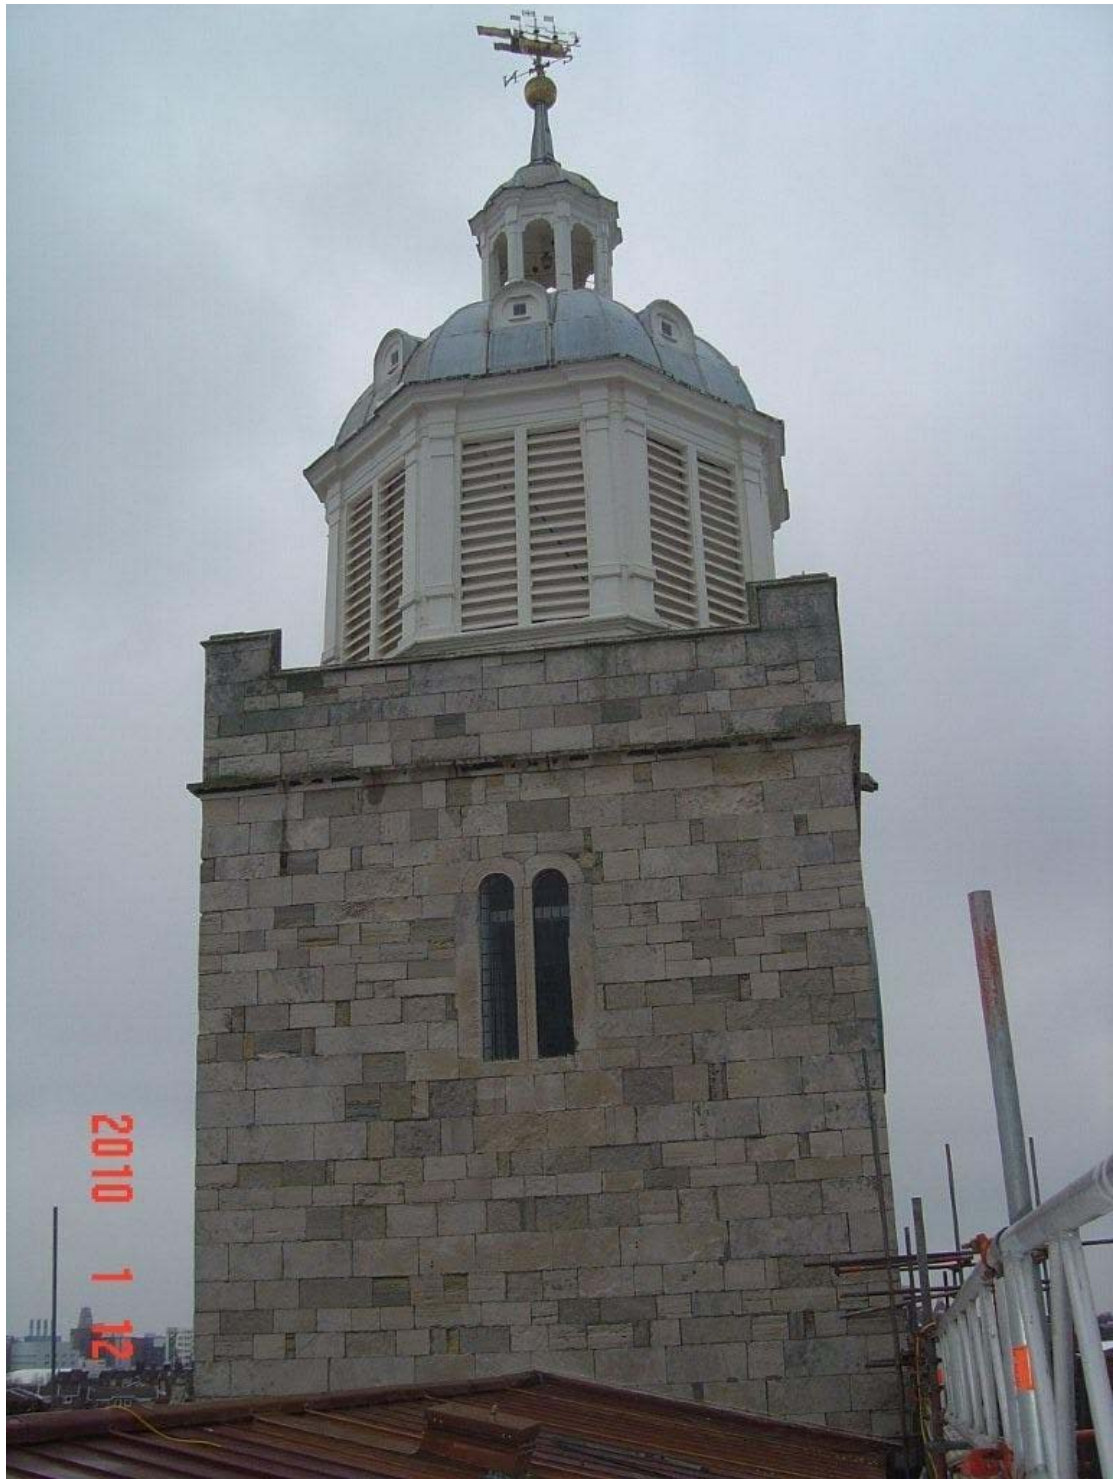
Tower and Cupola after repair and redecoration

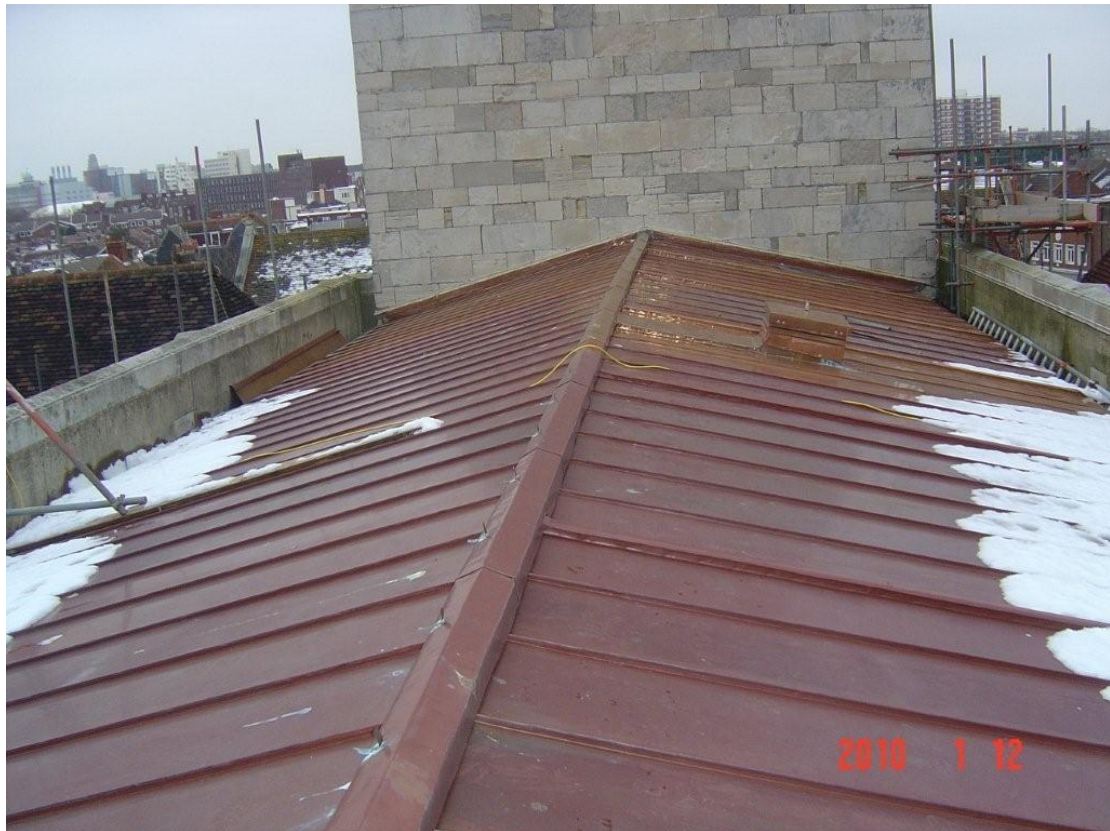
New copper roof over the Nave main aisle

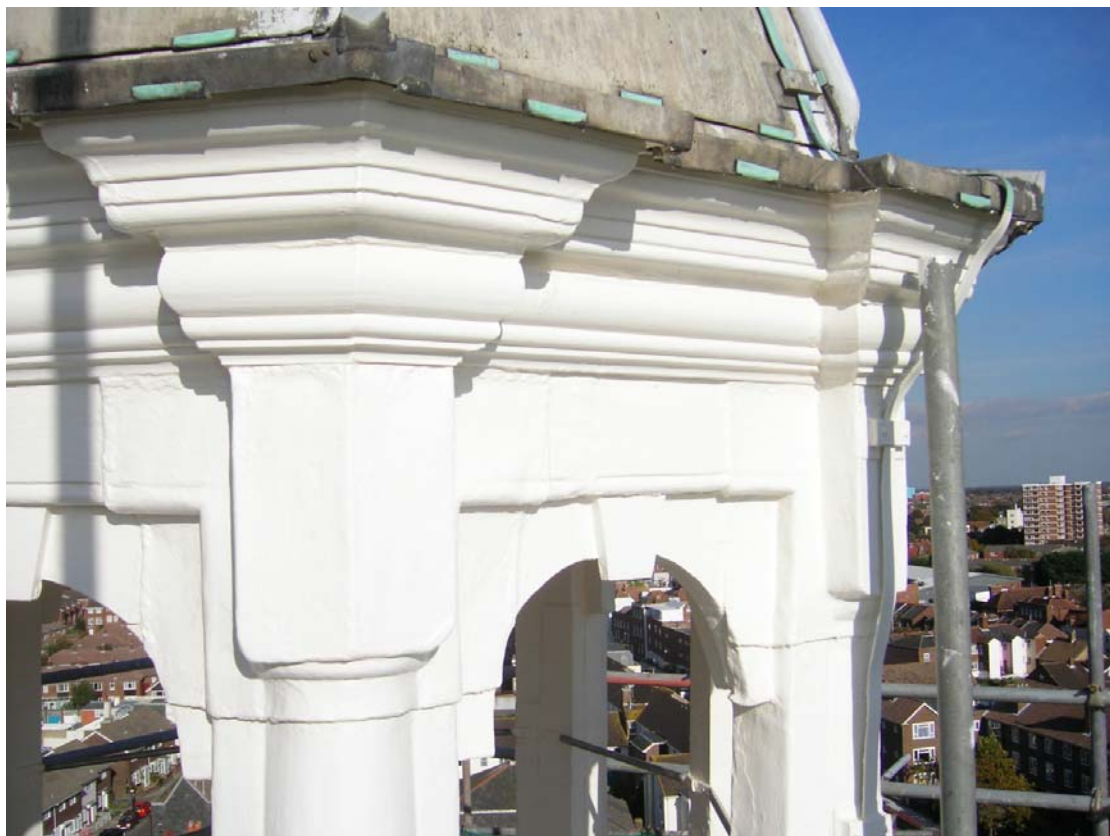
Repaired and redecorated lantern – south facing elevations.

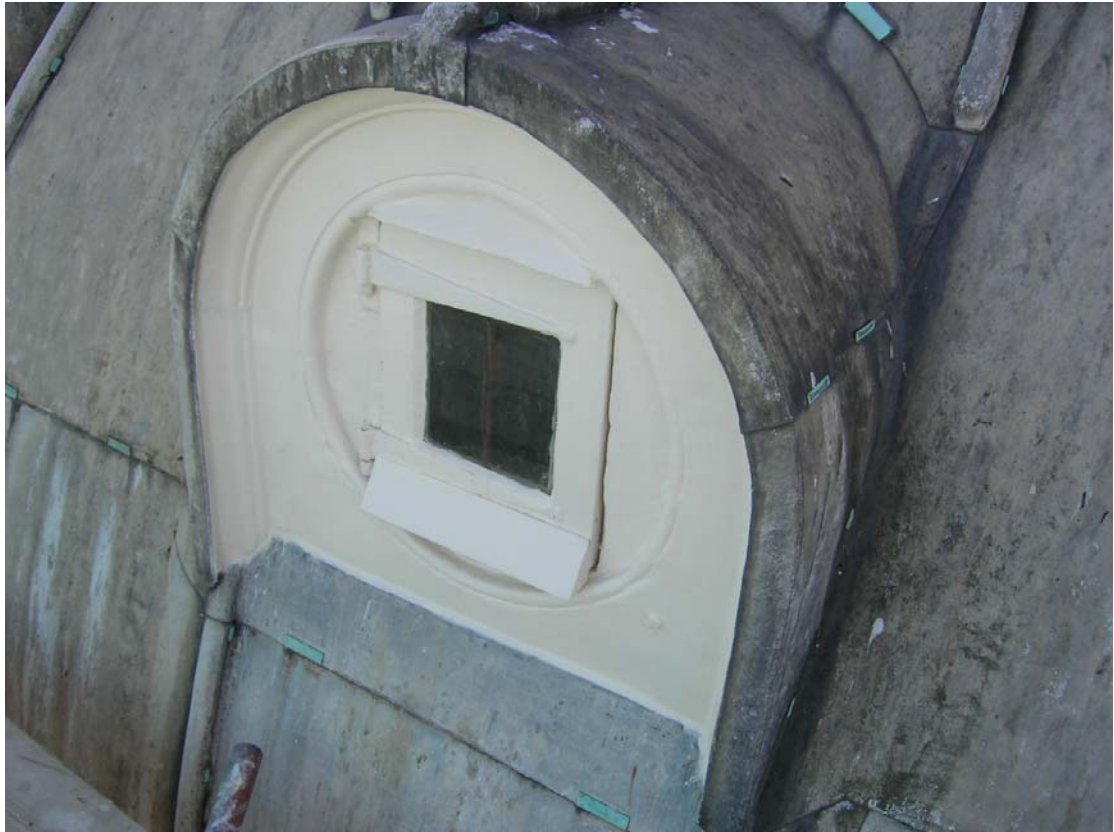
Repaired and redecorated timber casement window within main cupola roof. One of eight similar dormer windows.

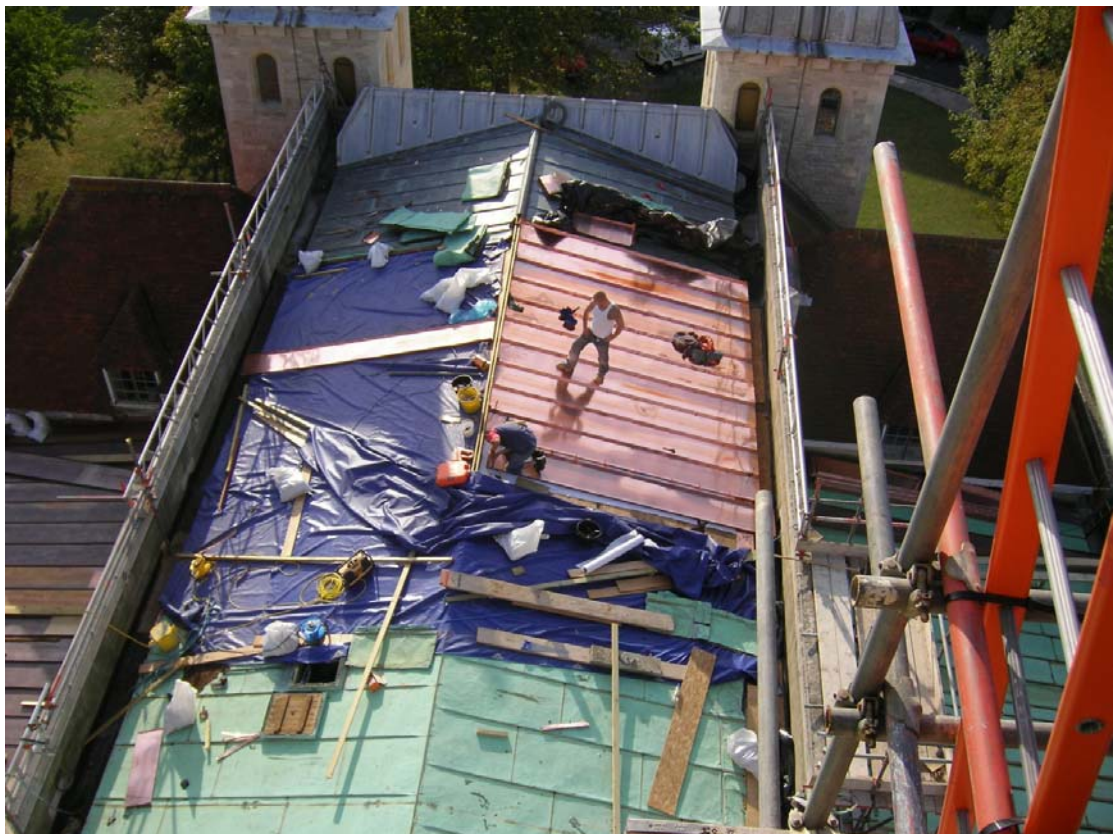
Long strip copper roofing to Nave roof – north slope.

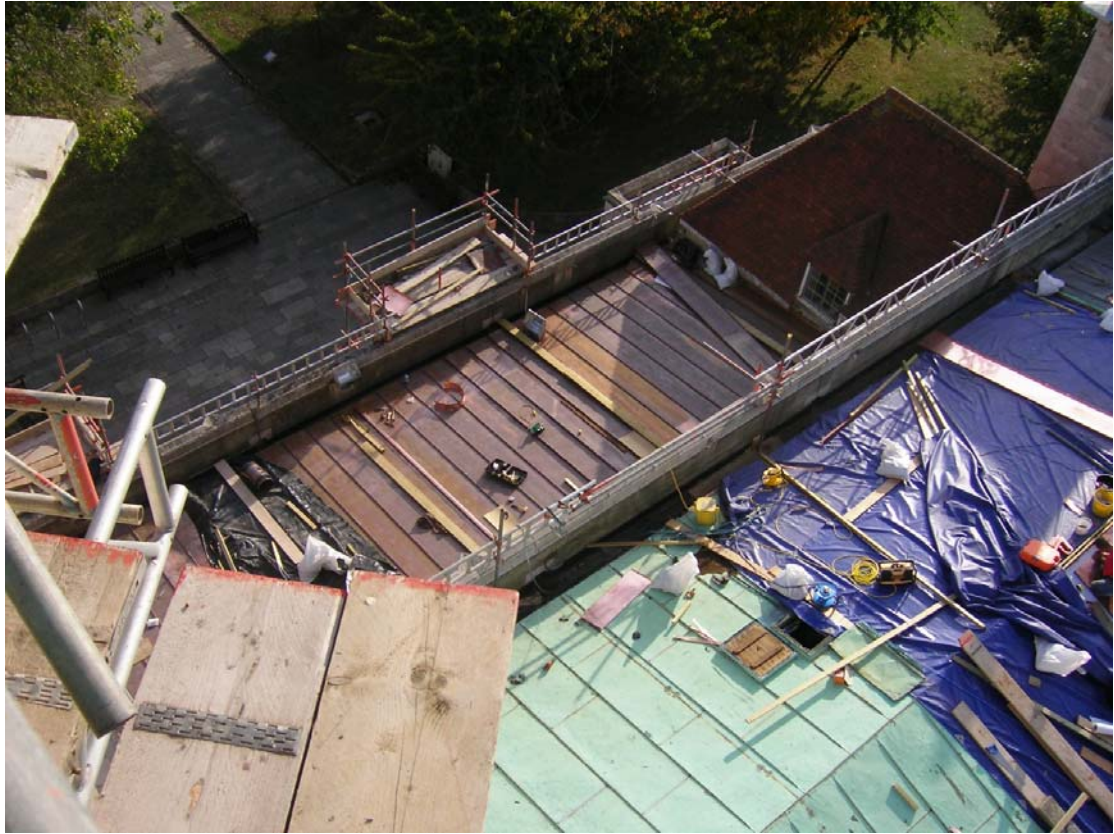
Long strip copper roofing to South Aisle roof.

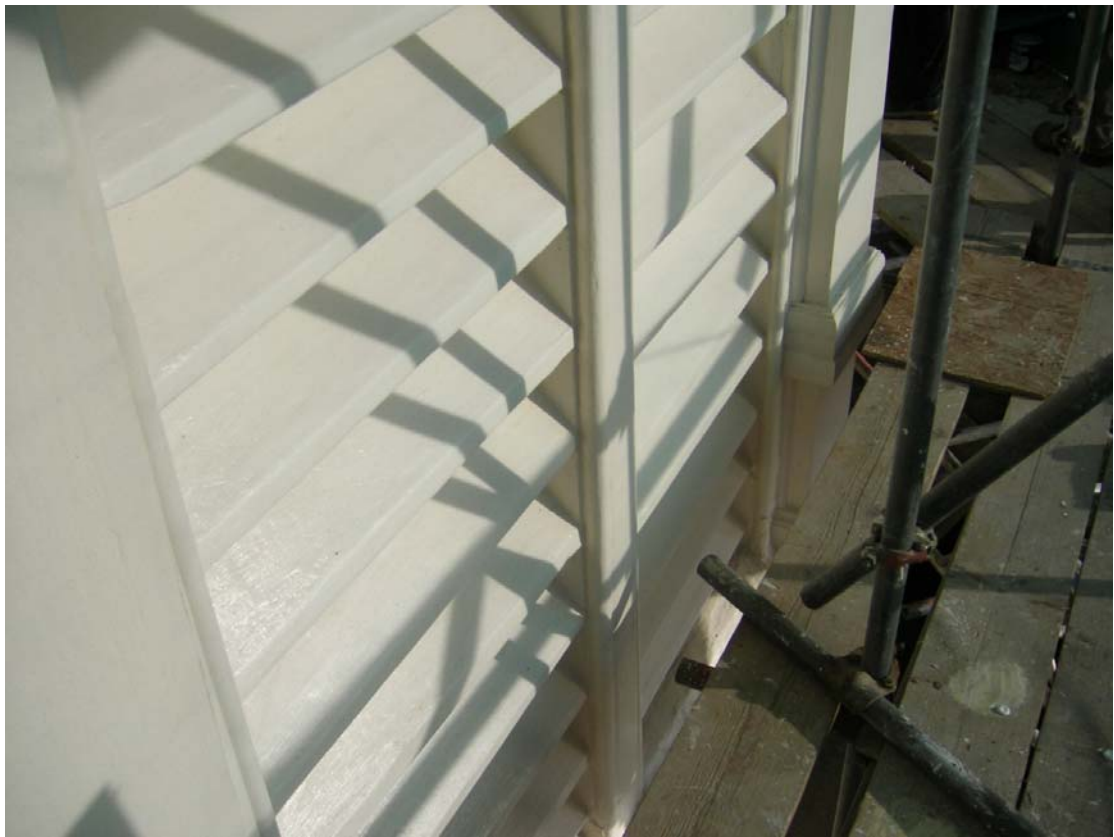
Louvres to the Belfry. Some of the louvres were decayed and have been replaced with new.

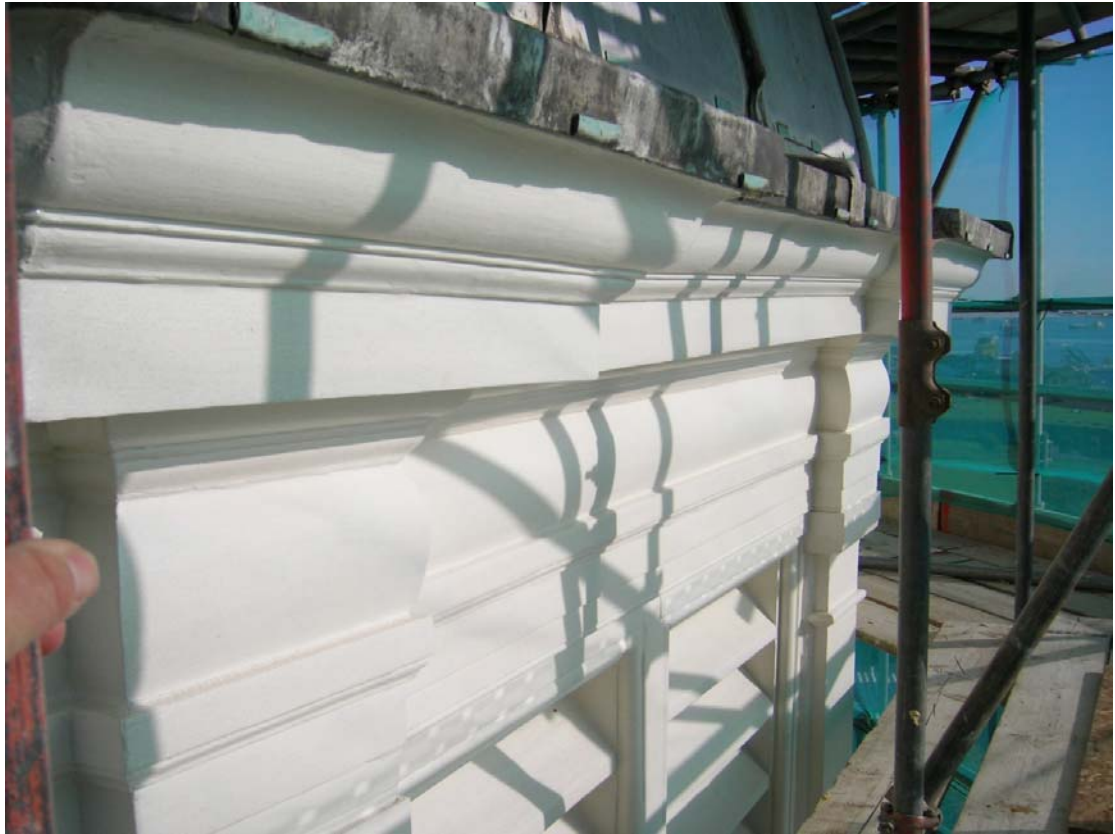
Cornice and mouldings above Octagon Louvres to the Belfry.
